Interlocking Concrete  
Pavement Institute®

## Your requested ICPI Tech Spec **07** follows this page.

## Repair of Utility Cuts Within Interlocking Concrete Pavements

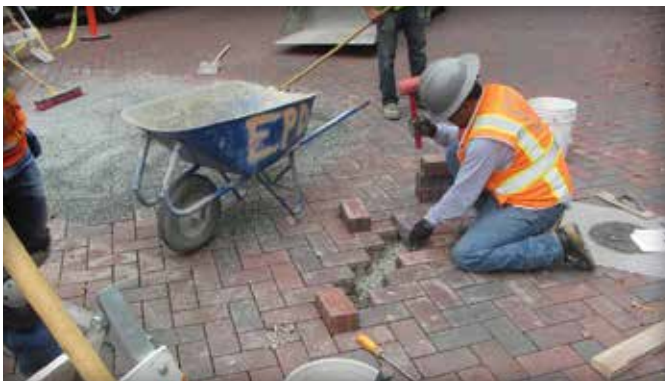
Figure 4. Reinstatement using the same pavers continues following the existing herringbone paving pattern.

Figures 2, 3, 4, 5 and 6 show the process of repair and illustrate the continuity of the paver surface after it is completed. The

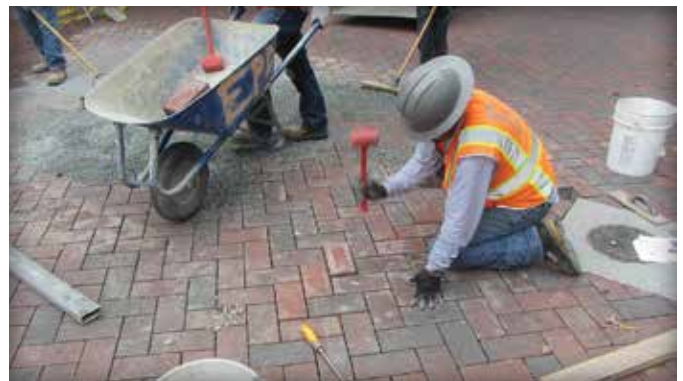
Figure 5. The final paver is inserted, the reinstated area compacted, joints filled, and compacted again. There are not cuts or damage to the pavement surface.

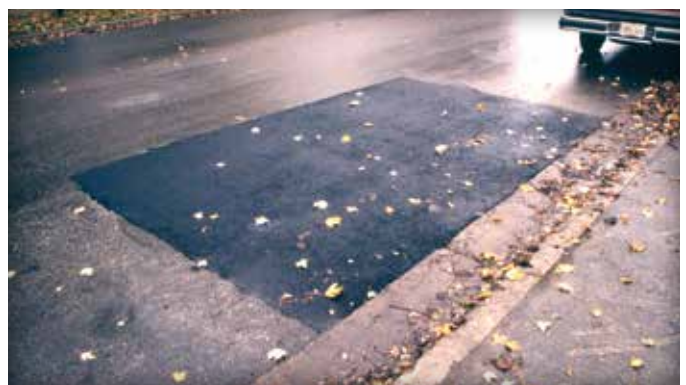
Figure 7. Pavement damage from settlement and shrinkage of cold patch asphalt.

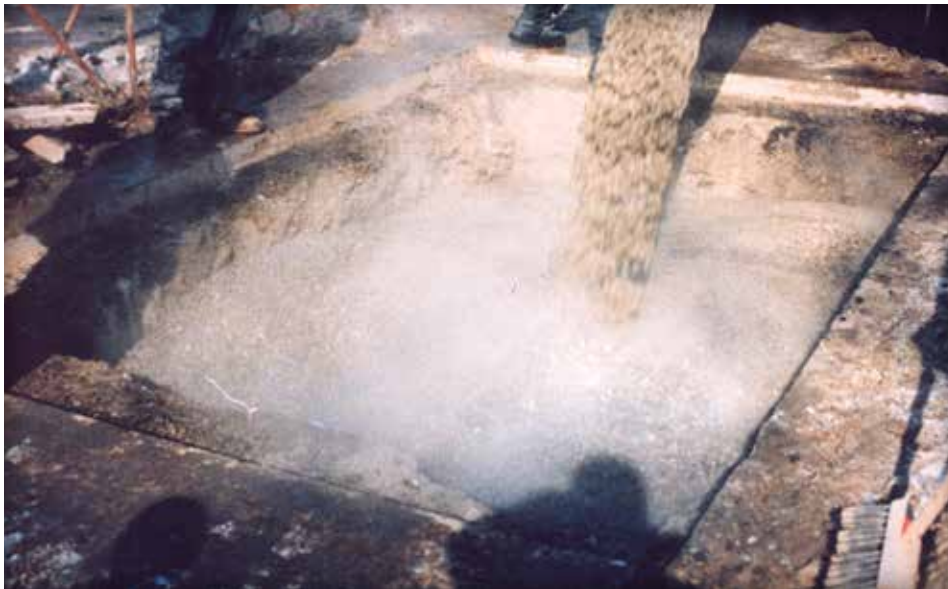
Figure 8. Low density concrete fill (unshrinkable fill) poured into a utility trench from a ready-mix concrete truck.

**Unshrinkable fill** poured into a trench is shown in Figure 8. The fill flows into undercuts providing additional support, and in places where the soil or base has fallen from the sides of the trench. These places are normally impossible to completely fill and compact with aggregate base or backfill material.

There are many mixes used for low-density concrete fill (7)(8). Proprietary mixtures include those made with fly-ash that harden rapidly. Others are made with cement. A recommended mix can be made with ASTM C150 (9) Type I Portland cement (or Type 3 for winter repairs), or CAN3-A23.5-M type 10 (or type 30 Portland cement) (10). The slump of the concrete should be between
